THE RECONSTRUCTION OF THE  
TYMPANA  
OF ST. SOPHIA AT ISTANBUL

ROWLAND J. MAINSTONE

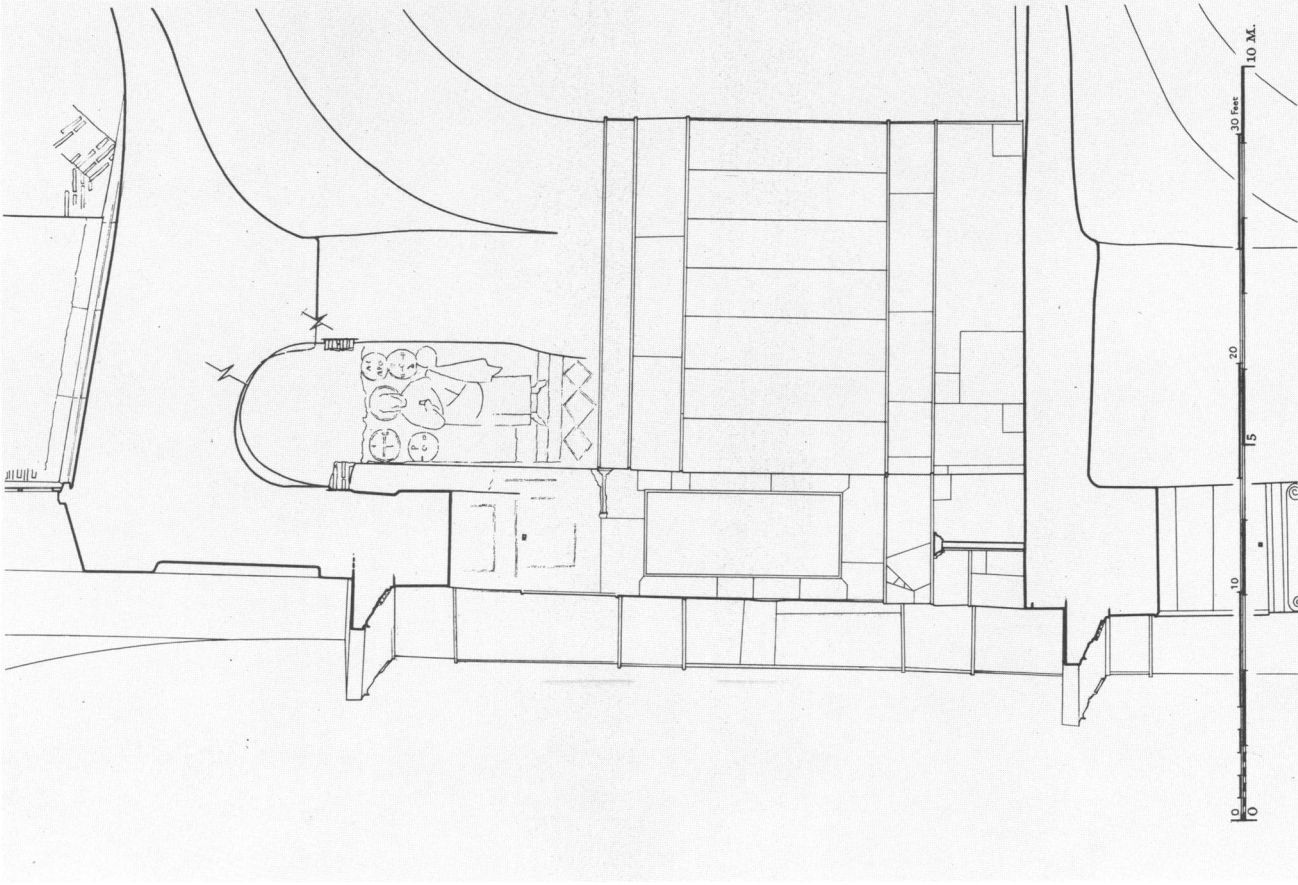
1. Alexander Mosaic and Northeast Pier and Pilaster at Gallery Level

gallery level, than the arcade itself, and the excess width is terminated just above the upper cornice (fig. 1). The openings were made immediately above these truncated pilasters and the only significant observation was that of a completely unbonded join between the brickwork of the pier and that of the springing of the barrel vault at the southeast.

There is no indication that the pilasters which receive the ends of the arcades (fig. 1) ever carried anything to justify their present excess width. This excess appears always to have been abruptly terminated, as now, at the level of the upper cornice. It seems to be explicable only in terms of a change in the design when the main piers had already reached some height above the gallery floor but work had not yet started on the arcades. It has been tentatively suggested<sup>20</sup> that the intention may have been to make all the arcades at gallery level similar in design to those below, as was done at SS. Sergius and Bacchus.

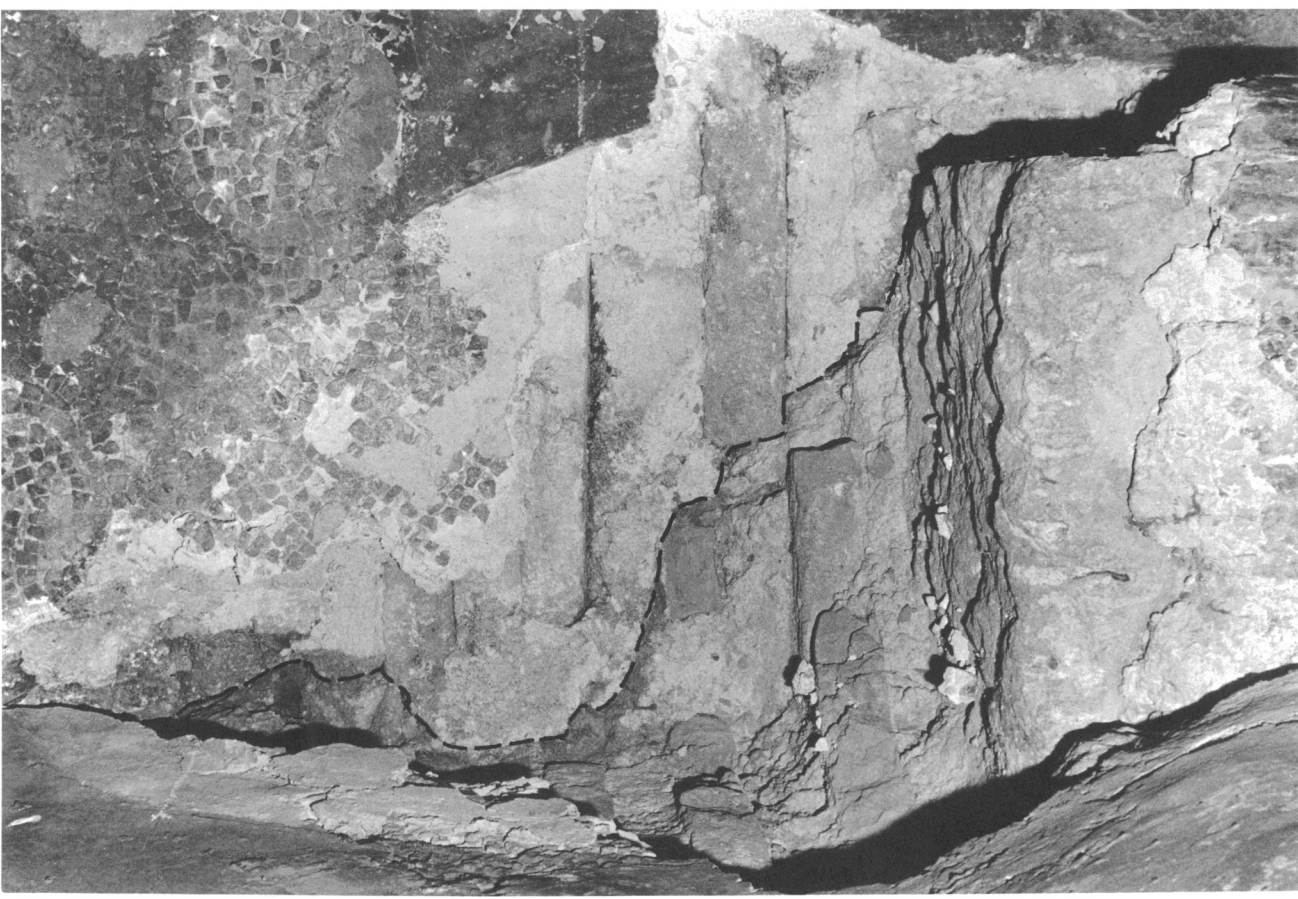
2. Springing of Barrel Vault above Northeast Truncated Pilaster.  
Detail, looking South

It was now apparent that the unbonded join observed by Van Nice in 1966 above the truncated pilaster attached to the southeast pier was part of the join between the original brickwork of the pier and the reconstruction. Some further uncovering above the corresponding pilaster at the northeast, and fresh holes above those at the southwest and northwest, laid bare the joins there also (D on folding plate, and fig. 2).

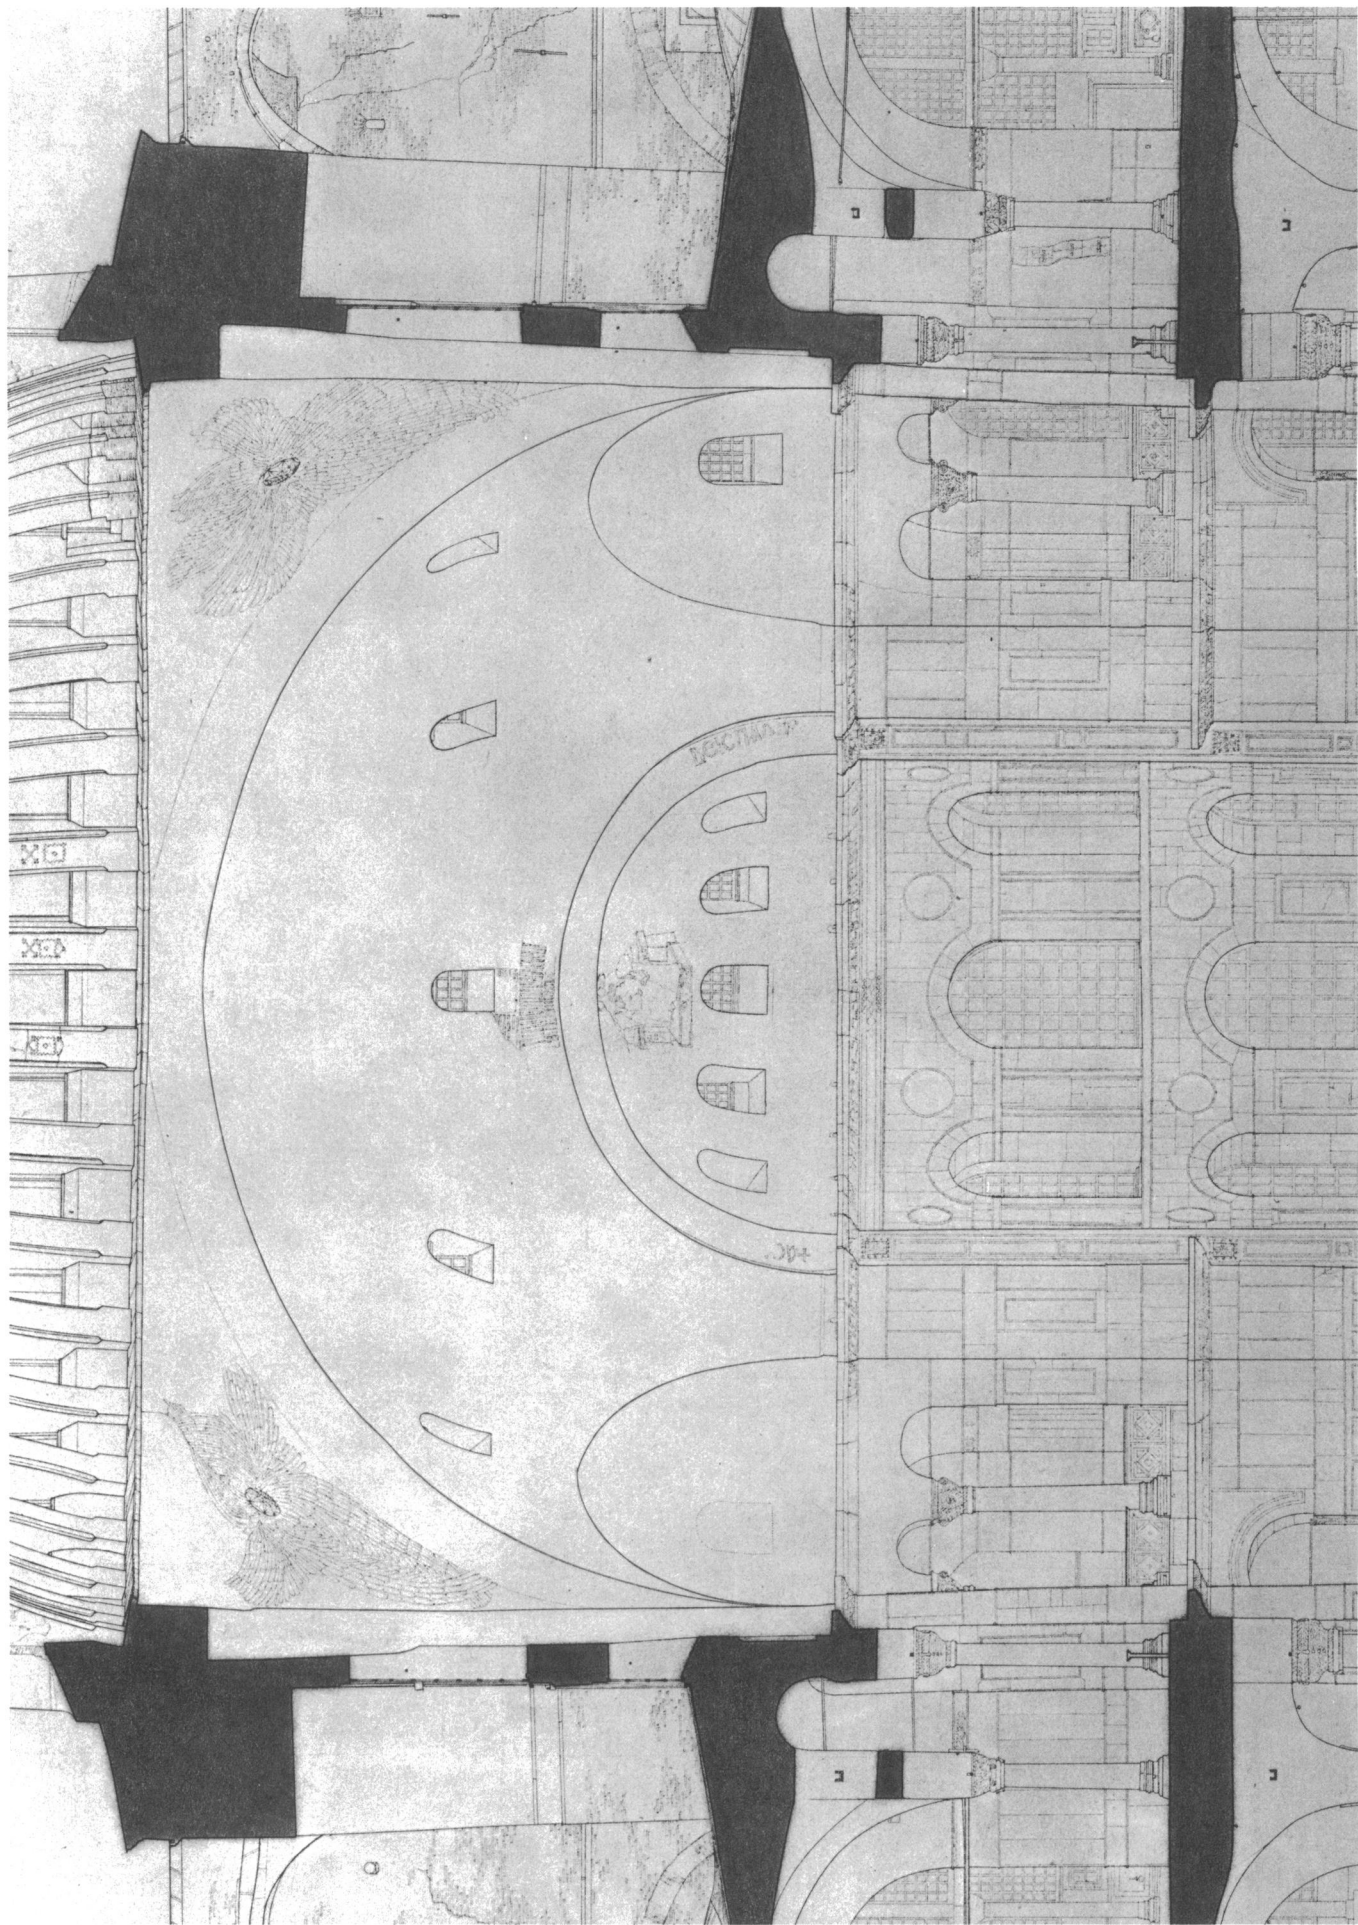
3. Istanbul, St. Sophia. Transverse Section (1:200)

Some of these characteristics of the tympana and arcades are illustrated in more detail in relation to the surrounding structure in figure 3.<sup>4</sup> The outward leans of the main piers commence well below gallery level but increase there about threefold to about 3 cm. for every 1 m. rise. Above the upper cornice two arches at each side carry the pendentives and the dome. The lower arches (referred to here as the main arches) span only the clear distance between the piers and are the full width of the piers, excluding the added width of the projections from which the great east and west arches spring. Above the gallery roof they are prominently revealed on the exterior. Since, however, the tympana are constructed with their inner faces continuous with those of the arches, they show today on the interior only as discolorations in the stucco which betray the pattern of the underlying brickwork, as shown more clearly in Salzenberg's partly conjectural engraving reproduced in figure 4.<sup>5</sup> The upper arches span the considerably greater distance between the projections from the piers just referred to and, like the east and west arches, directly carry the pendentives. Their outer faces are now hidden within the dome base so that their width is indeterminate, but their soffits are partly revealed on the interior.

The exposed faces of both the main and upper arches lean outward at their springings at the same angle as the piers from which they rise. There is a marked difference, however, between the outward displacements of their crowns, and this difference is both greater than and of opposite sense to the small one which would result merely from the greater rise of the upper arches. The difference corresponds to a progressive increase in the width of the exposed soffit of each upper arch as it rises, the main arches being of uniform width throughout. Thus, the crowns of the upper arches are displaced outward some 35 cm. less than would be expected as a result of the outward leans at the springings, while the crowns of the main arches are, on the contrary, displaced some 15 cm. further than would be expected. The inner faces of the tympana are, of necessity, displaced outward at their heads to the same extent as the crowns of the main arches. Instead of a gradual warping outward of these faces toward the center, though, the slope is almost uniform for most of their height throughout their length and there is a conspicuous adjustment in the last 3 m. The outer faces, if some local slight irregularities are ignored, have a uniform slope throughout with no adjustment near the head and, as noted by Underwood and Hawkins, this slope is much less than that of the inner faces. As the section shows, it is very similar to that of an imaginary plane drawn through points on the face of either upper arch at its springings and its crown.

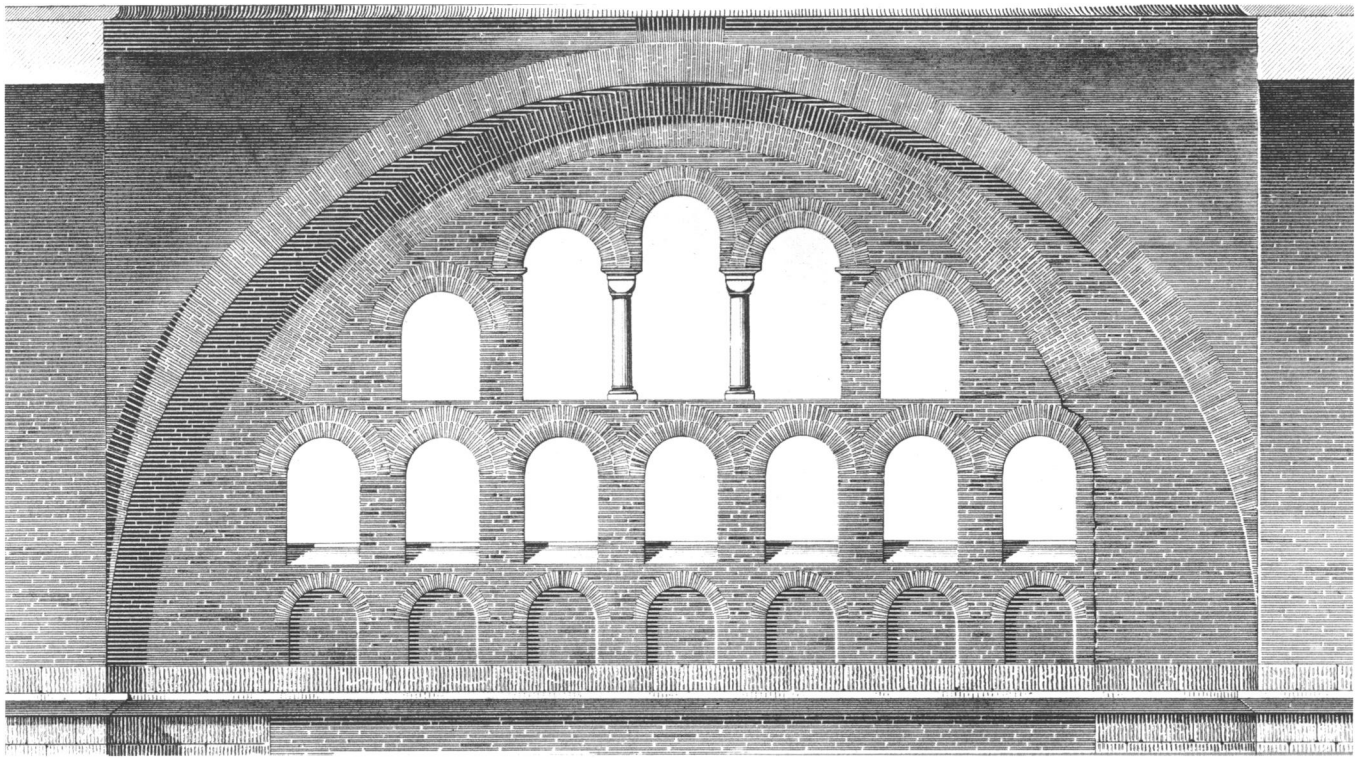
4. South Tympanum, Interior Elevation, according to Salzenberg

<sup>5</sup> From W. Salzenberg, *Alt-christliche Baudenkmäler von Constantinopel vom V. bis XII. Jahrhundert...* (Berlin, 1854), 21. Apart from its failure to show the joins between the original structure and the reconstruction and to represent more faithfully the major cracks and the precise geometry of the present forms, the chief faults of that part of the engraving which is reproduced are the representation of a non-existent course of stone above the upper cornice and some incorrect or implausible details in the representation of the brickwork.

<sup>19</sup> Paulus Silentiarius, *Descriptio Sanctae Sophiae*, line 536 (in P. Friedländer, *Johannes von Gaza und Paulus Silentiarius* [Leipzig-Berlin, 1912], 242), refers to eight windows in all. Assuming that there were, as now, seven in the lower range answering directly to the bays of the arcade below, this means that there can only have been one above. A possible form of this is illustrated in K. J. Conant, *op. cit.*, pl. xxxviii. The present groups of three windows referred to are those shown in the Salzenberg engraving (fig. 4) without the later narrowings of the openings.

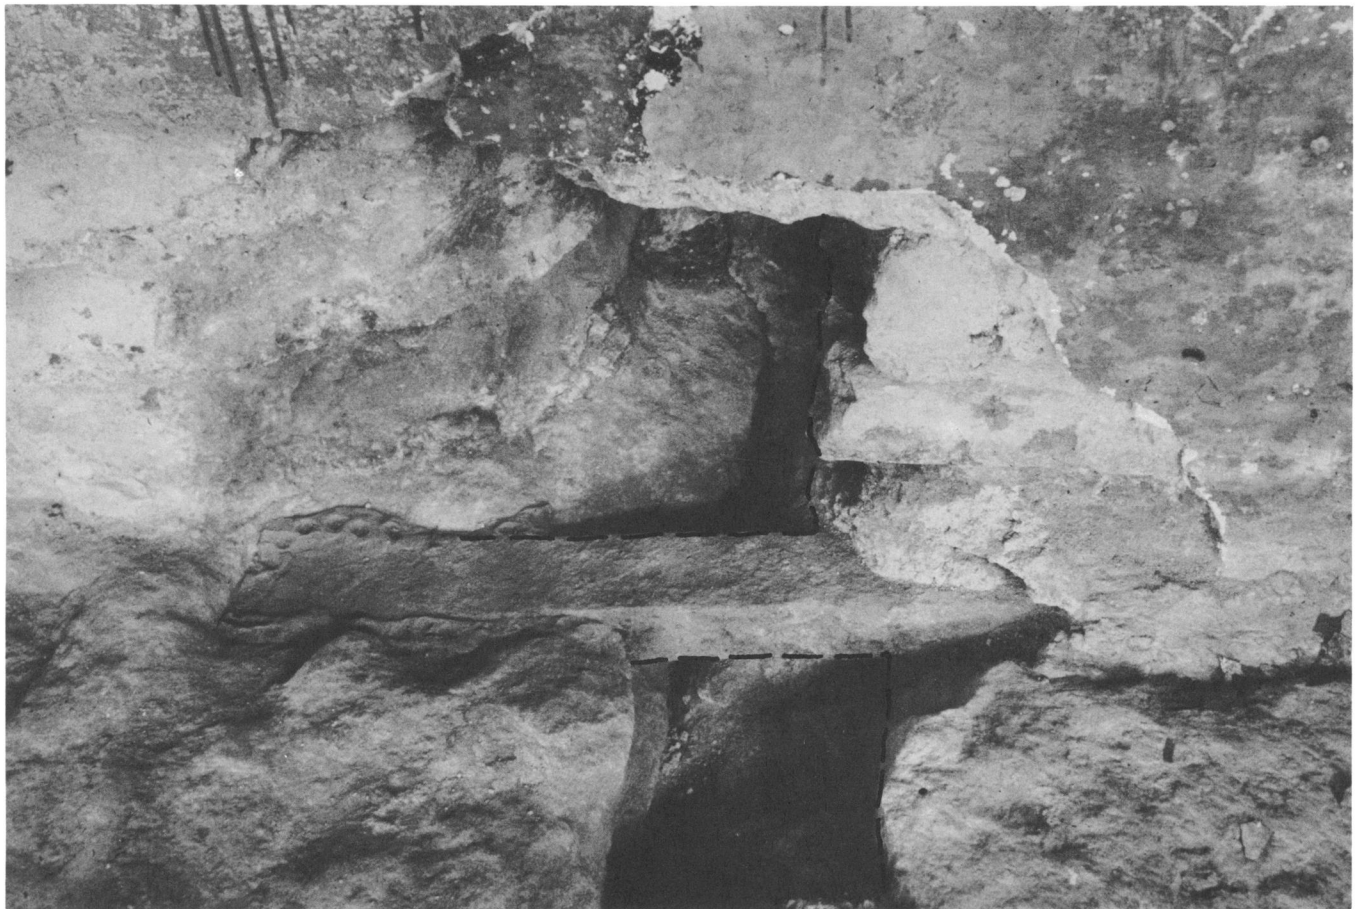
5. North Tympanum, West End. Detail of Test on Upper Cornice

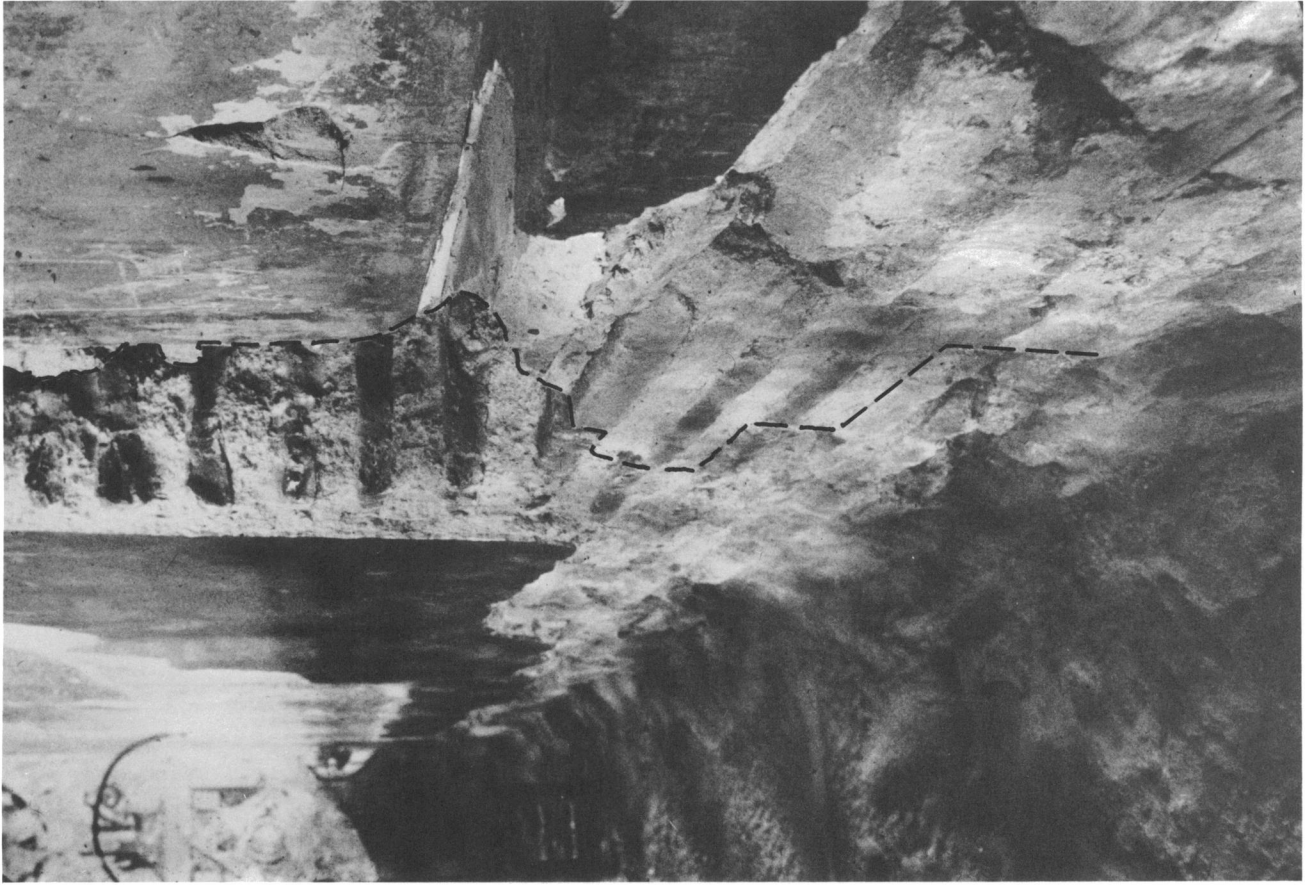
6. South Tympanum, Easternmost Niche

At the south it was possible to extend both openings sufficiently to follow the joins into the shallow niches. As expected, the original brickwork had been cut back obliquely at each end. More significant was the discovery that only in the reconstruction had the niches been formed from the start. In the two places where they now extend into the original brickwork they had been cut out of a mass that was originally of uniform thickness (figs. 6, 7).

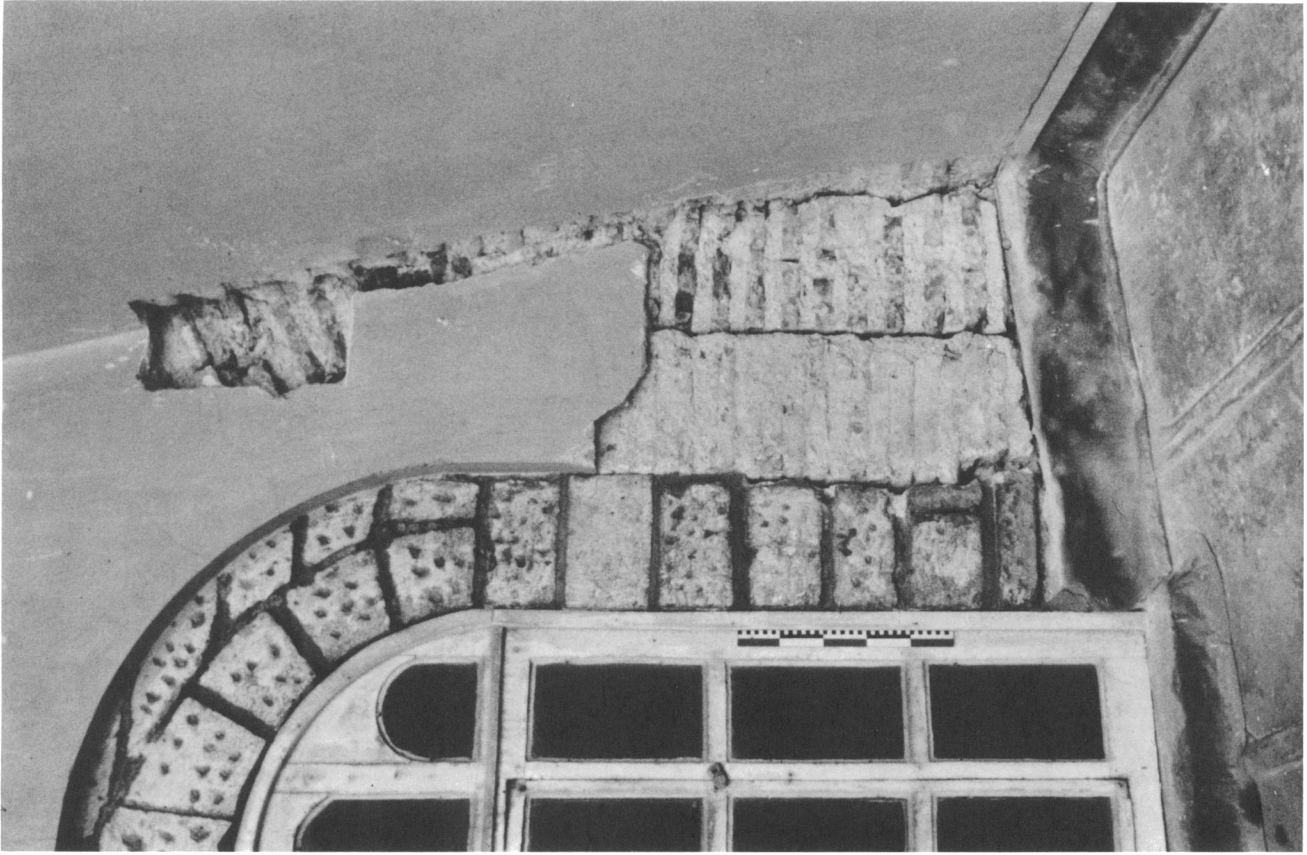
8. North Tympanum, West End, Exterior

Permission to look for the joins having been granted, the stucco was removed first in the area of the previous test just above the roof at the southwest, then in the corresponding positions at the other three extremities, and, finally, at the level of the springing of the window arch at each extremity. Since this removal proved to be particularly revealing at the northwest and the stucco was relatively loose, a larger area was subsequently uncovered there (folding plate and figs. 8, 9).

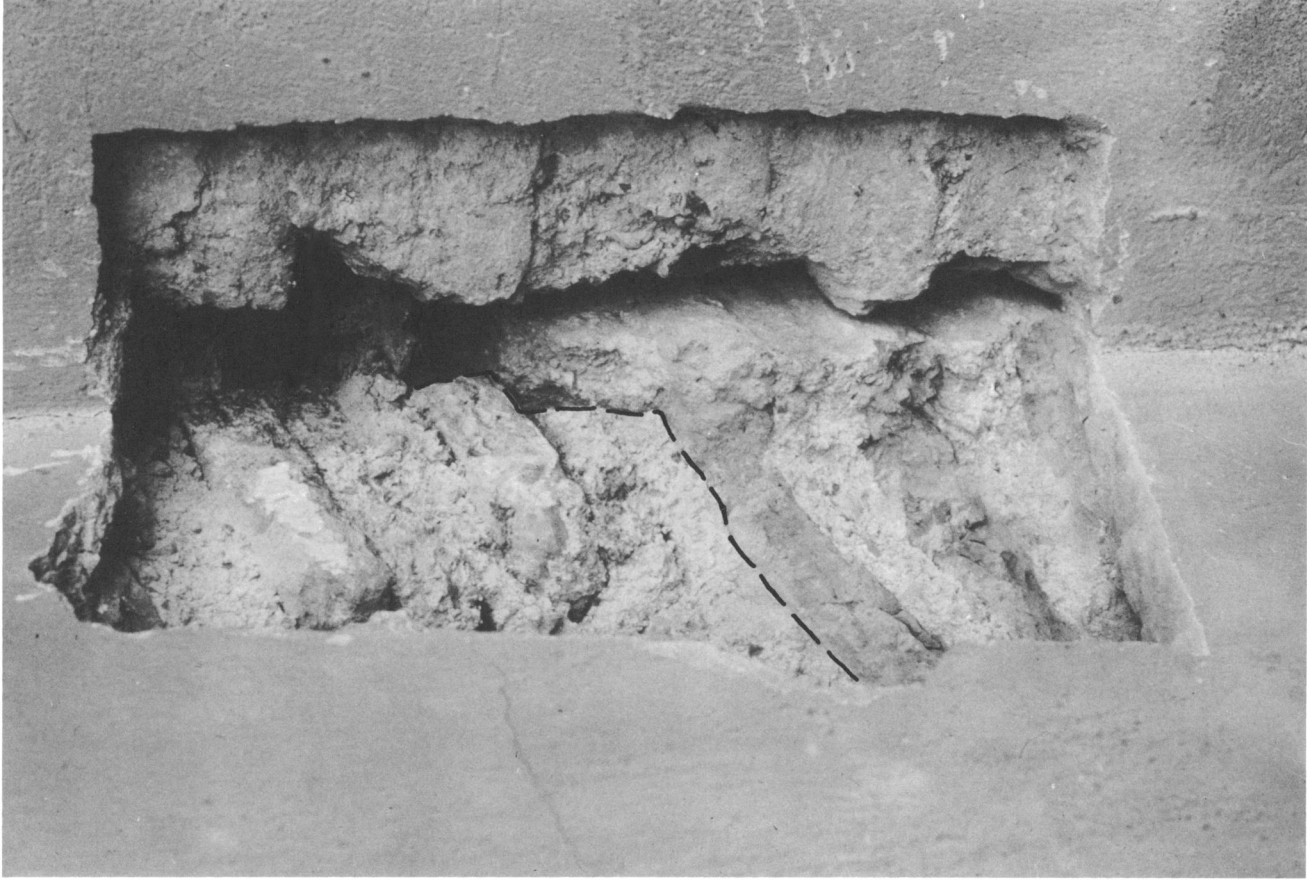
9. Upper Test seen in Figure 8. Oblique Detail

and not part of the rebuilding that followed the partial dismantling during initial construction that is referred to by Procopius.<sup>11</sup> Here a normal bond became impossible, and the few bricks that remained of each window arch extended as one unit into the mass of the main arch. The pointing on their faces also extended into this mass, indicating that these window arches had been constructed first and the main arches then built up around them (fig. 9).

In relation to the earlier conclusion that the greater verticality of the outer faces of the tympana, as compared with the inclinations of their inner faces and the main piers, denoted a rectification at the time of reconstruction, the direct evidence of rectification that was discovered was particularly interesting. Enough remained of the original outer faces to show that they did indeed incline outward to the same extent as the main piers. To avoid surface discontinuities of several centimeters at the joins it was necessary, therefore, to adjust the inclination of the new work locally to match that of the original or to trim the face of the original back alongside the join. The latter alternative was adopted at the northwest and southeast, where the trimming back of the original faces could be very clearly seen at the level of the window arches (fig. 9).

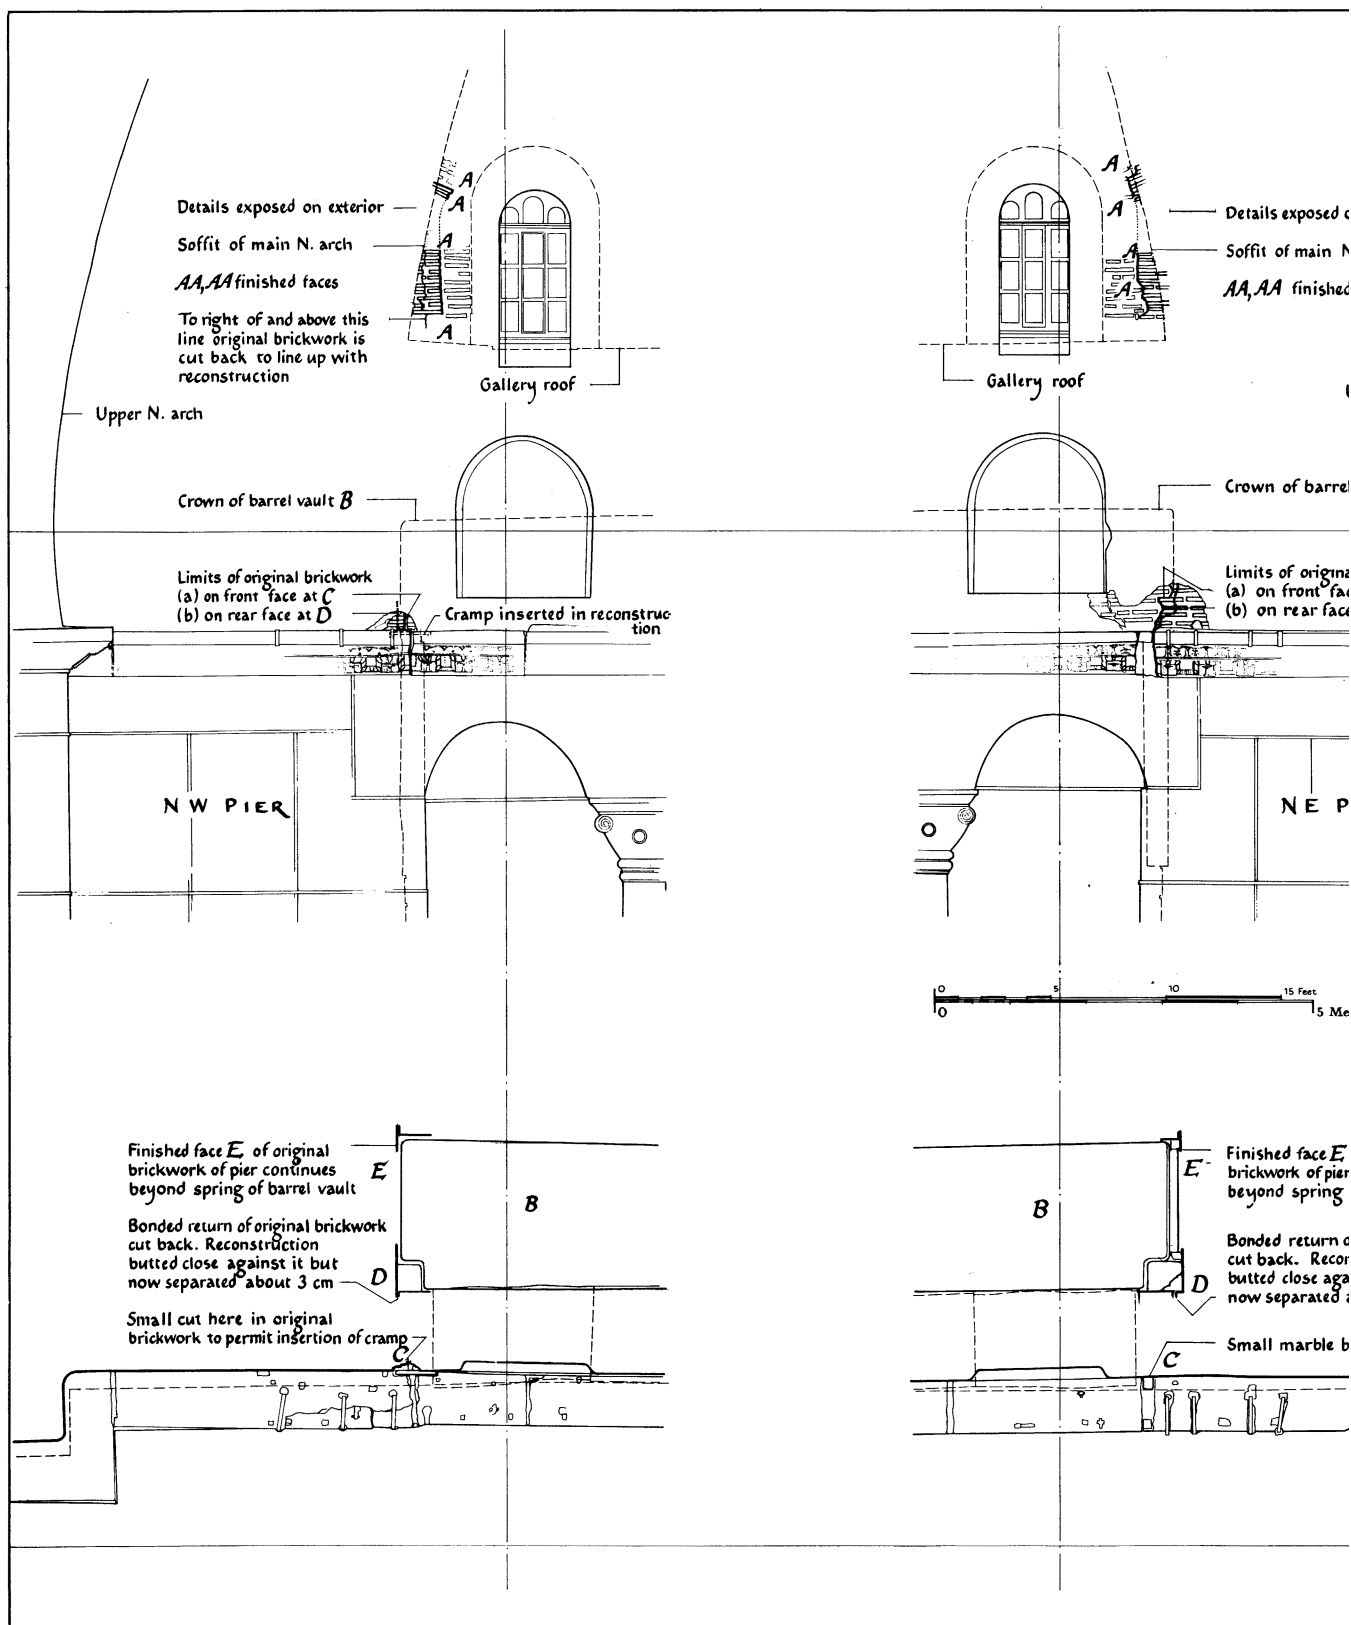
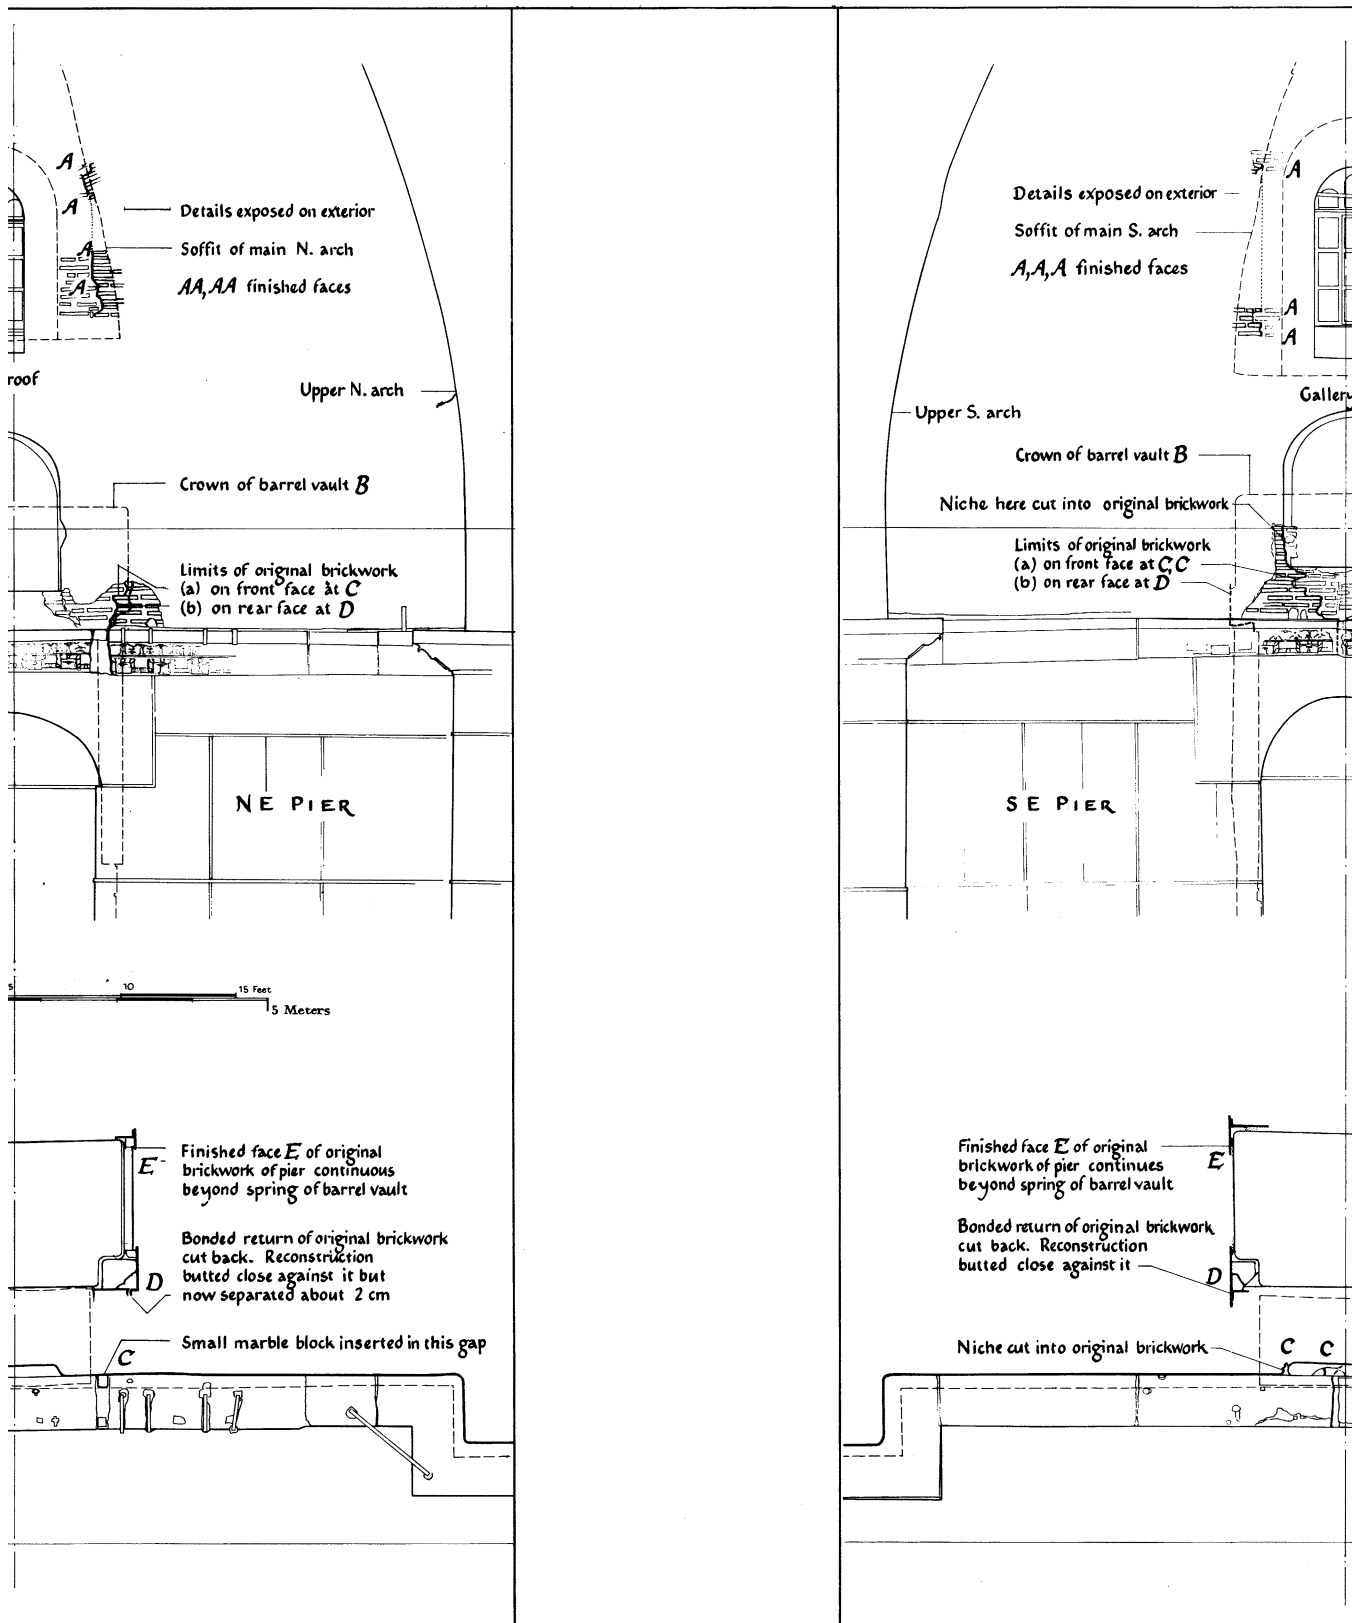
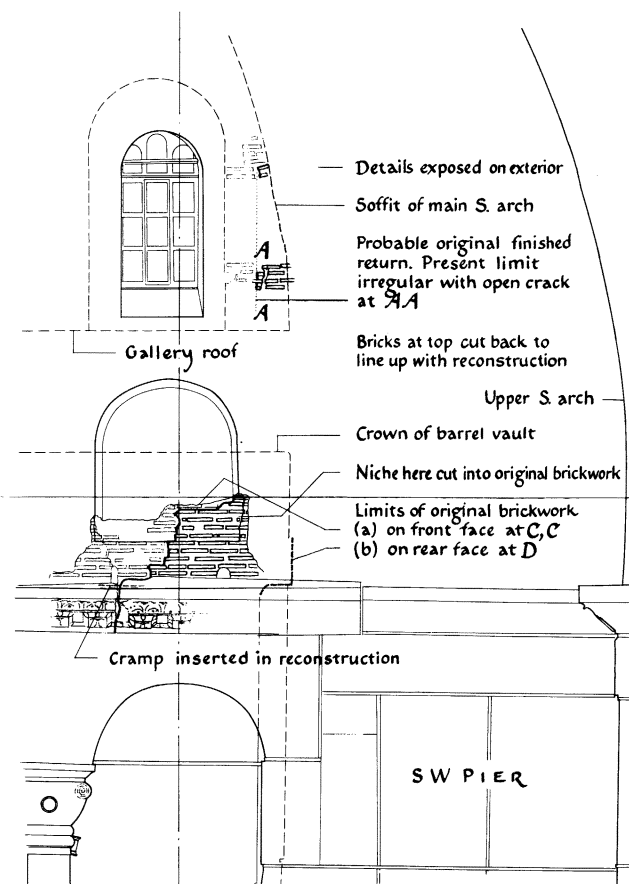
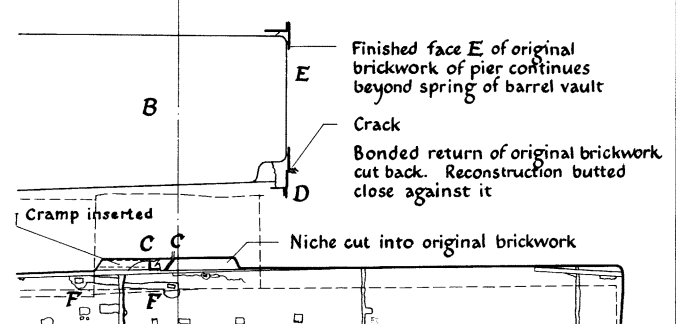
Istanbul, St. Sophia. Interior Elevations and Plans of Ends of Tympana, showing (in heaviest line) observed Limits of Reconstruction (1:100). Details exposed on Exterior are depicted in Reverse, as if seen from Interior. Plans are drawn just above Level of Upper Cornice.

To supplement the picture obtained from the tests above the truncated pilasters, four more smaller openings were made in 1968 at the outer ends of the barrel vaults (E on folding plate). Here the brickwork of the vaults belonged entirely to the reconstruction and no original bonded returns were found. In every case the finished face of the brickwork of the pier continued uninterrupted behind the springing of the vault. This did not necessarily indicate that the original vaults had a different form. They would almost certainly have been constructed after the piers, and normal practice would not demand a bond in such situations where relative movement might be anticipated but need not be regarded as serious.

The original form was best displayed at the northwest. Here the finished (pointed) jamb and part of the finished soffit of one window opening had been left untouched, with the new work simply butted up against them (AA on folding plate, and fig. 8). Elsewhere the original jambs had been cut away to a varying extent. At the southeast this seemed to have been done deliberately to bond in the new work. The irregular joins at the southwest and northeast may, however, simply have followed the lines of earlier cracks.

The extent of the reconstruction of the upper cornice, the tympana, and the barrel vaults behind the tympana was well defined by these tests (folding plate), but no tests were possible on the faces or soffits of the arcades below the cornice, on the arches that carry the outer springings of the barrel vaults, or on the gallery vaults beyond these arches. In considering the full extent of the reconstruction it is necessary, therefore, to rely on less direct evidence.
